CORROSION

FOLLOWING TRADES

TECHNICAL BULLETIN CTB-17

Rev 4, November 2003

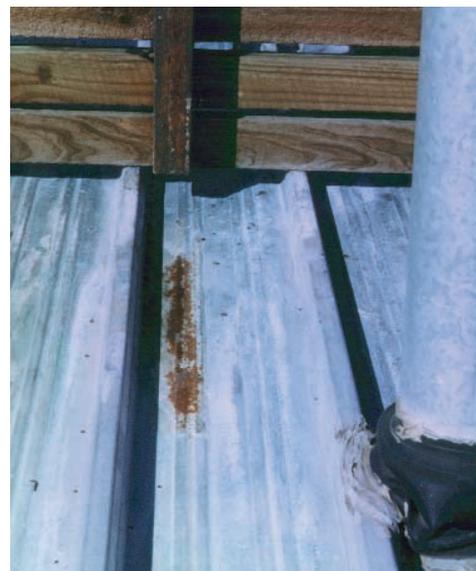
Figure 1: CCA Treated Timber Walkway

The installation of surface mounted roof air conditioning units on copper/chrome/arsenic (CCA) treated timber or green hardwood dunnage and the installation of roof walkway systems similarly mounted on this style of timber dunnage must be avoided. Corrosion of the under lying roof sheeting in contact with the timber will be dramatically accelerated by the wet poultice and contaminants created by such poor practice.
