# RECOMMENDED STEEL GUTTER SYSTEMS

## TECHNICAL BULLETIN TB-15

Rev 6, November 2003

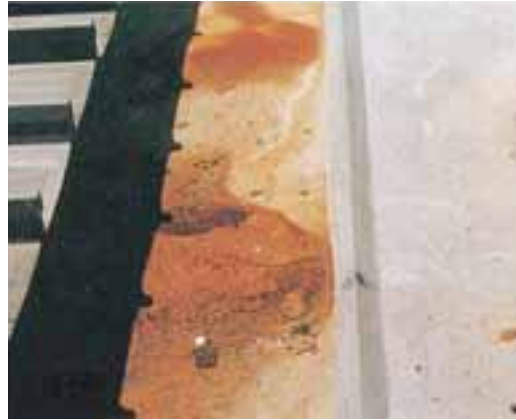
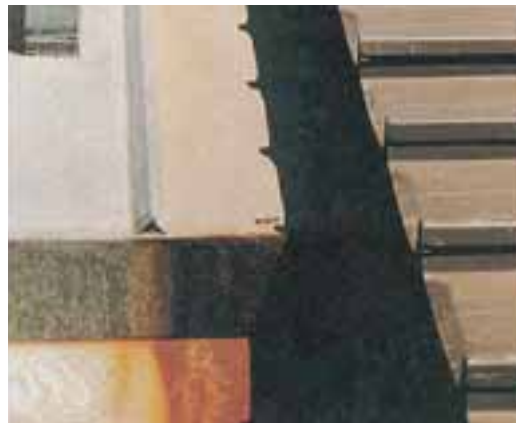
Early gutter failure occurred in all the box gutters and downpipes within eighteen months. This early failure can be directly attributed to the “inert catchment” phenomenon, caused by high purity rain water dripping or flowing into the gutters and sumps over extended periods. Replacement of the gutter system after only 18 months was required. An inefficient building, an angry client and possible legal proceedings were the result of a lack of knowledge of the reasons for early gutter failure and the inert catchment phenomenon. Also noted were areas of severe

corrosion with complete loss of protective coating – these were associated with ponding, where water had been retained for long periods, such as run off from the air conditioning plants.

### CORRECT SPECIFICATION PROVIDES THE ANSWER

The solution to the problem of early gutter failure lies simply in the knowledge of the mechanism of corrosion. Therefore, the correct specification of a gutter and down-pipe product that will not result in surface breakdown will become a standard detail.

Research carried out by BlueScope SRL has proved that ZINCALUME® steel and ZINCALUME® based COLORBOND® steel used as a gutter and downpipe product in combination with any traditional roofing material will perform the desired non-corrosive functions of a gutter and downpipe system far better than zinc-coated material.

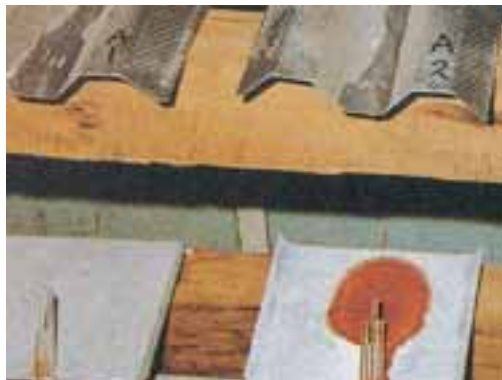
1 Aluminium to ZINCALUME® steel gutter (*left*)  
Aluminium to zinc-coated (*galvanised*) gutter (*right*)

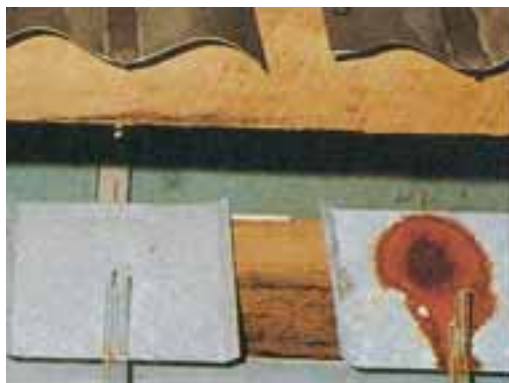
2 COLORBOND® steel to ZINCALUME® steel gutter (*left*)  
COLORBOND® steel to zinc-coated steel gutter (*right*)

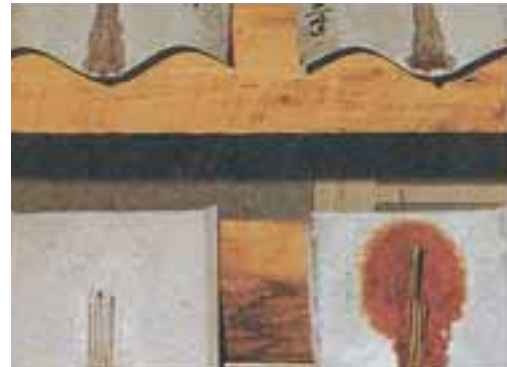
3 ZINCALUME® steel to ZINCALUME® steel gutter (*left*)  
ZINCALUME® steel to zinc-coated steel gutter (*right*)

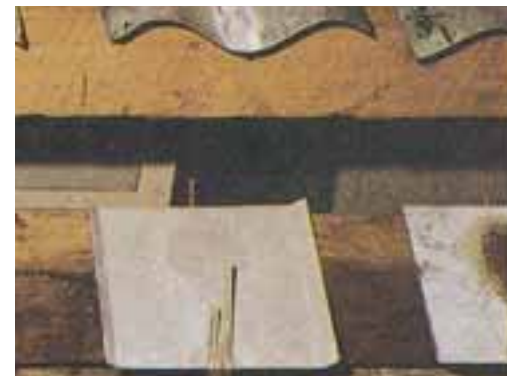
**Note:** Picture 4 shows that corrosion has occurred on a zinc-coated sample below a zinc-coated roof. This result indicates that zinc-coated steel will eventually fail before ZINCALUME® steel in a similar situation.

The test on the ZINCALUME® steel sample was abandoned when no rusting was evident even after it had been exposed without failure for more than 17 times the period to rust formation on the zinc-coated sample.

4 Zinc-coated steel to ZINCALUME® steel gutter (*left*)  
Zinc-coated steel to zinc-coated steel gutter (*right*)

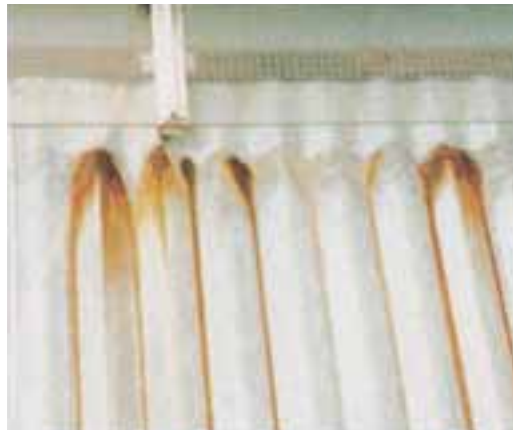
Zinc-coated roof receiving water from glass roof.

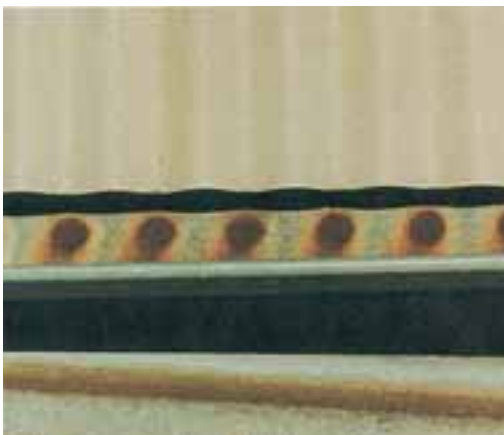
Early failure of zinc-coated gutter receiving water from pre-painted zinc-coated steel roof.

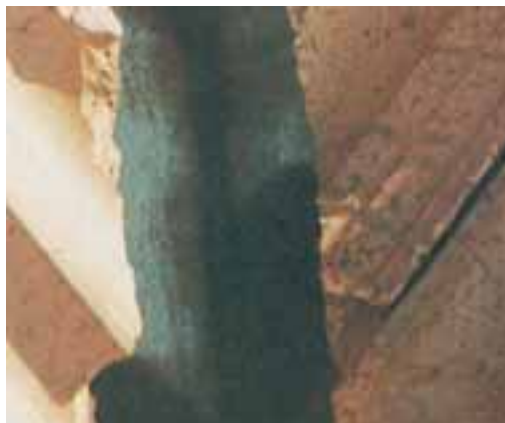
Typical early failure of zinc-coated gutter receiving water from terracotta roof.
