Identification of fungus in the field and recommendations for its removal

The purpose of this Technical Bulletin is to provide insight to the occurrence, characterisation, identification and cleaning of fungus. A variety of building materials are susceptible to fungal growth, however, the information provided in this Technical Bulletin relates primarily to COLORBOND® pre-painted steel.

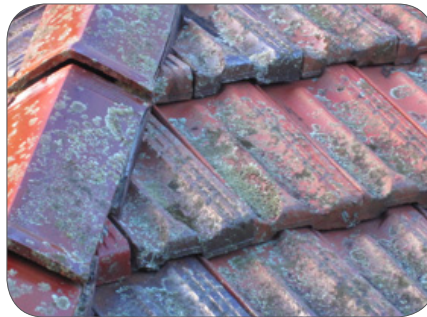
Figure 1: An example of lichenous growth across the surface of a tiled roof.

environment is particularly favourable, lichens may also be occasionally seen, usually across the entire roofing surface. *Figure 1* provides an example of lichenous growth on a tile roof.

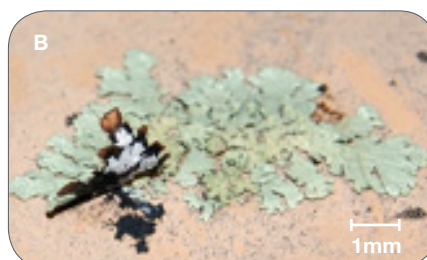
Figure 2: A close up of a) fungal and b) lichenous growth.

Areas affected by fungus may be divided into several basic types based on organism and distribution. Organisms visible on roofs can be broadly divided into fungus and lichen (a symbiosis of fungi and algae). While fungus is generally black, lichen appears green and often leafy. See *Figure 2*.

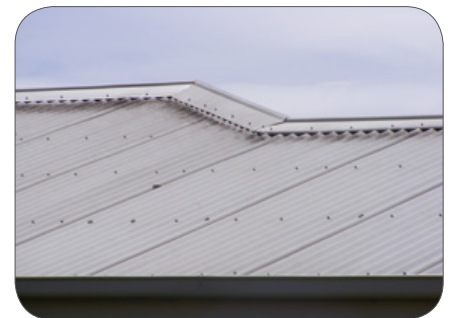
Figure 3: Photograph of a roof made from COLORBOND® steel showing isolated fungal growth in the vicinity of the ridge capping.

Heavy areas of fungal infestation on a building are often seen around the ridge-capping. See *Figure 3*.

It is believed that this “ridge cap” effect is due to the favourable micro-environment for fungal growth which exists in this area because of moisture and/or nutrients leaving the roof cavity at the junction of the ridge capping and the roofing sheets.

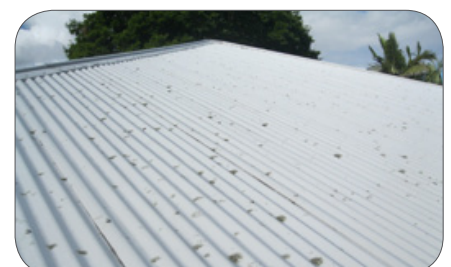
Figure 4: Photograph of a roof made from COLORBOND® steel showing spotty lichen and fungus growth spread across the structure.

Organic material may be present as overall clumps or dots spread across the roof. This often manifests as patches of lichen. See *Figure 4*.

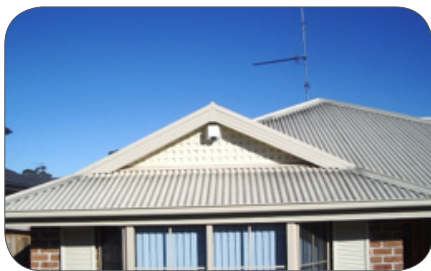
Figure 5: Photograph of a roof made from COLORBOND® steel showing uniform coverage of fungus. By way of comparison, note that the body of the roof was supplied in the same colour as the gable detail.

It is also possible for growth to not be isolated to any specific area but to cover the entire roof area. Such growth is normal on any outdoor structure where the local environment is conducive. When very heavy growth of this type occurs on lighter coloured roofs, the overall colour and appearance may be altered. See Figure 5.
